Inspection Order No. : IN-WH-5302-15015
BOSS No. : N/A
Page No. : 9 pages
Date of issue: Aug.31st, 2015

INSPECTION REPORT
(non-negotiable)

- Description and Quantity of Commodity: SMLS STEEL PIPE, 14MoV63, Φ153mm×25mm 10pcs
 SMLS STEEL PIPE, 14MoV63, Φ194mm×25mm 9pcs

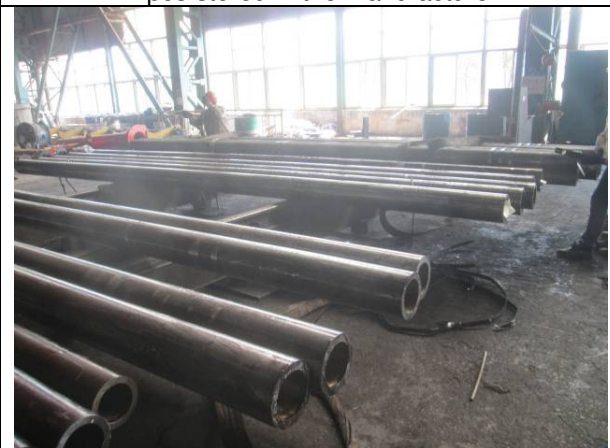
During this inspection, the visual quality check had been performed to all the pipes by SGS inspector. All pipes were straight, no bend or deformation was found. There was no crack, heavy scratch, dent or other visible defect was found on inside and outside surface of pipes.

Visual check for outside surface

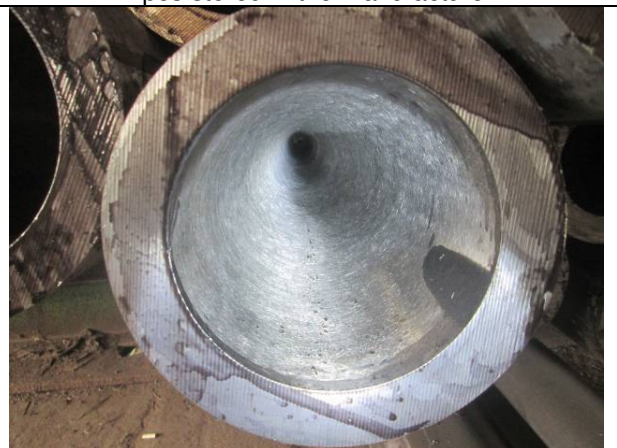
Visual check for inside surface.

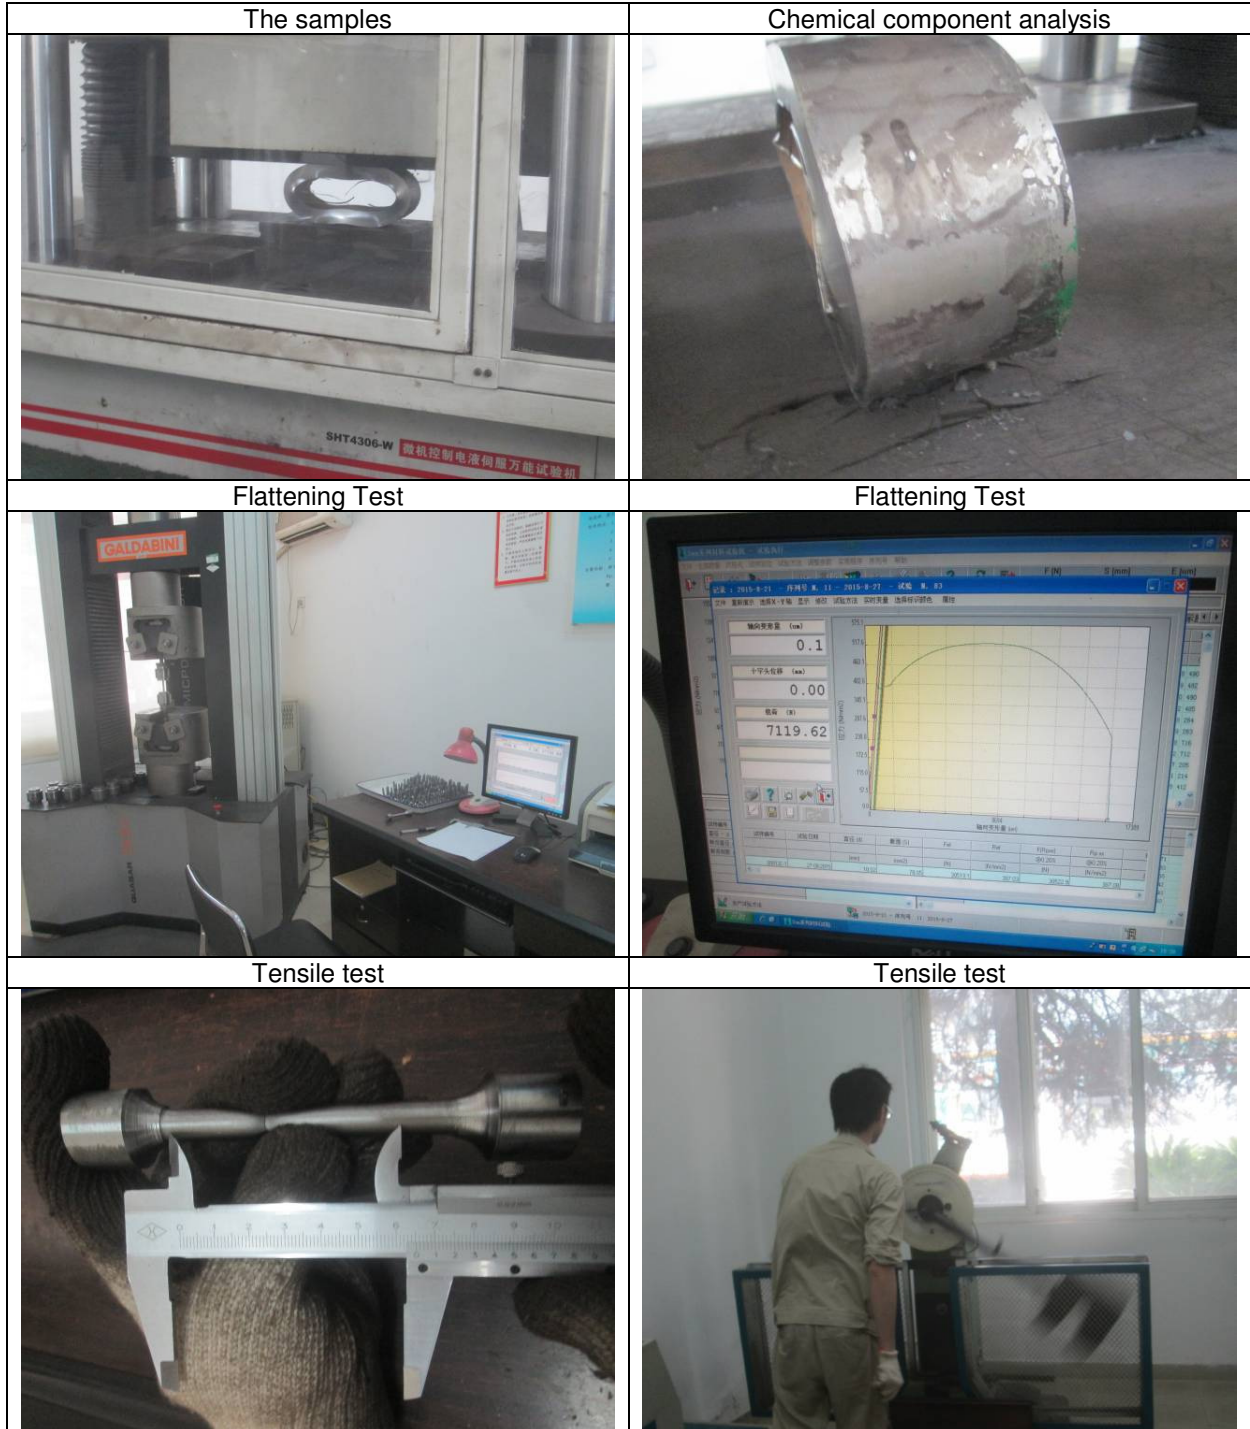
<p>Tensile test</p>

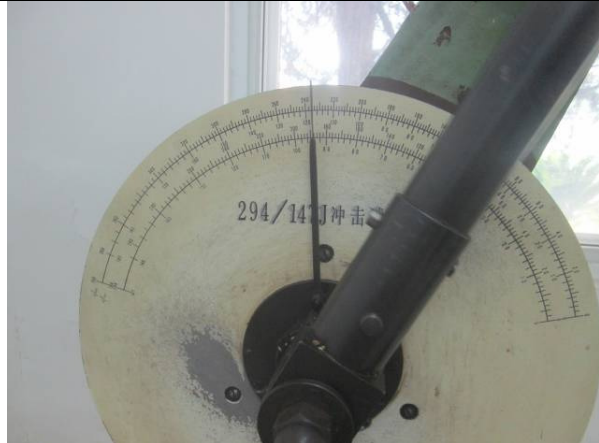
<p>Impact test</p>

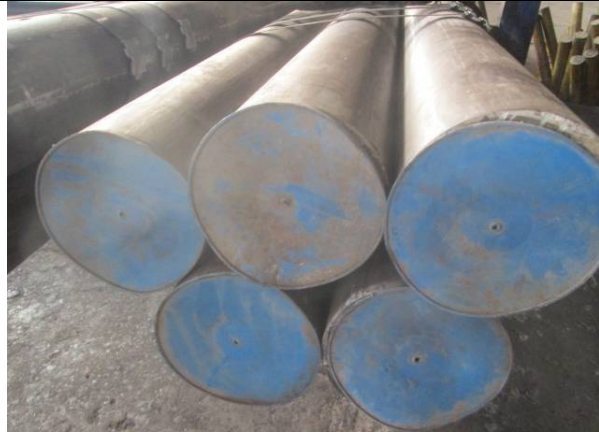
- The end of pipes was protected by plastic cap.
- The pipes were fastened with steel belt.

<p>Packing Check</p>

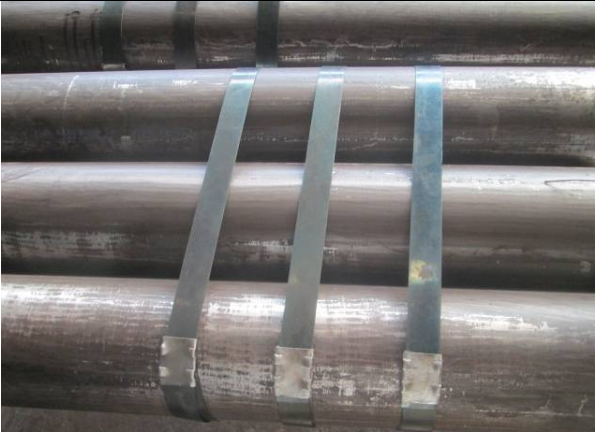
Packing Check	Packing Check
