Inspection Order No. : IN-TJ-5601-11488
Boss No. : 1097800
Page No. : 1 of 10
Date of issue: Jan.13, 2012

INSPECTION REPORT

- Description and Quantity of
Pipe EN10224 S275 508mm x7mm 85pcs
Pipe EN10224 S275 508mm x9mm 625pcs

- Inspection Date & Place: Jan.10-11, 2012, Cangzhou, Hebei

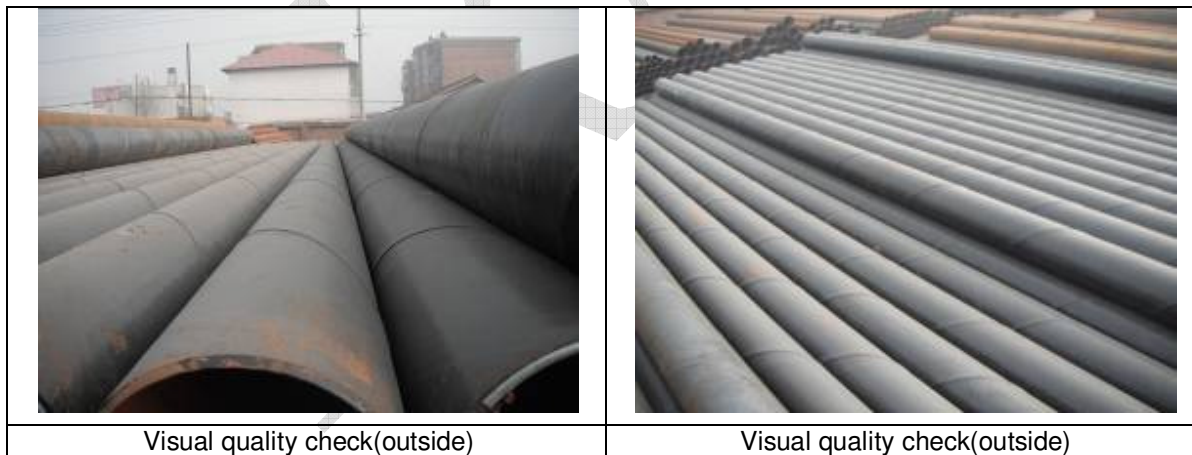
Visual quality check(outside)

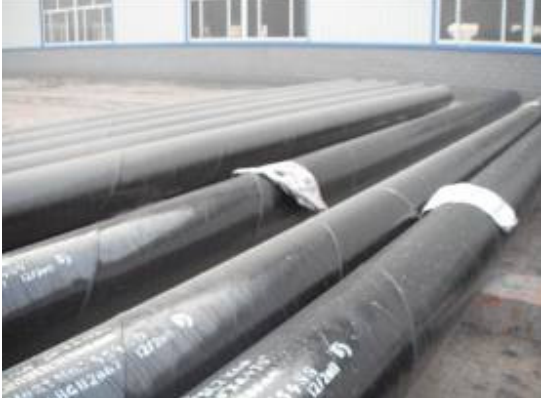
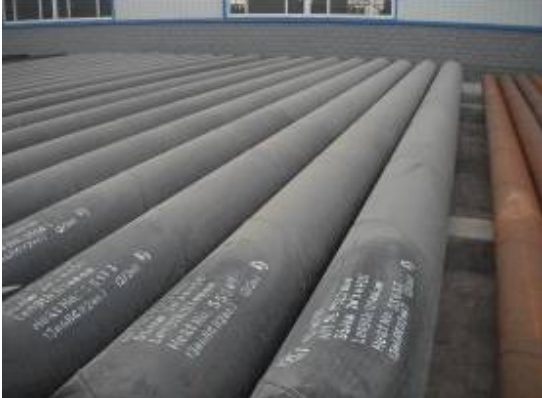
1.2 During the inspection, SGS inspector found there was corrosion inside of each pipe because of the remaining water of hydrostatic pressure testing, SGS inspector made reminded.

Visual quality check(outside)	Visual quality check(outside)

Visual quality check(inside)	Visual quality check(inside)

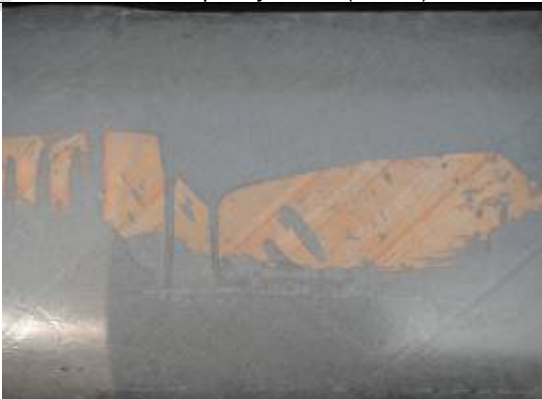
1.3 The paint outside of 13 Pipes was scratched, and the scratched part was corrosive, SGS inspector made reminded, the manufacture declared that the scratched part would be repainted before transport.

The paint was scratched	The paint was scratched

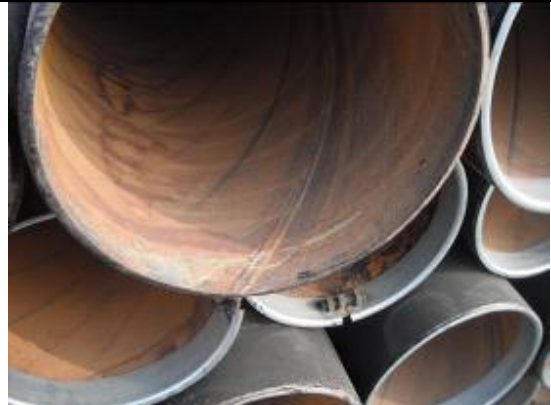
1.4 According to EN10224, for a distance of at least 100 mm (4.0 in) from each pipe end, the inside weld bead shall be removed by grinding such that it does not extend above the adjacent pipe surface by more than 0,5 mm (0.020 in), but the manufacture had not removed the weld bead, SGS inspector made reminded, the manufacture declared that they would remove the weld bead before delivery.

<p>Weld bead inside the pipe</p>	<p>Weld bead inside the pipe</p>

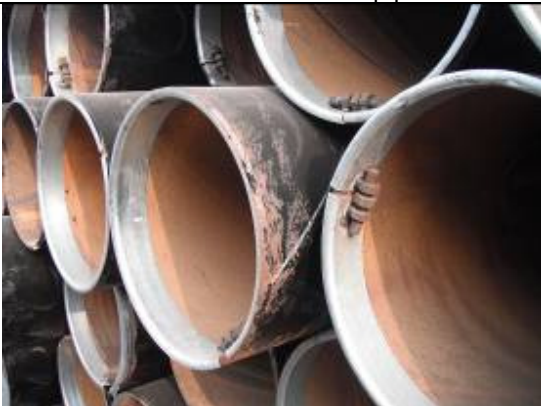
<p>Protectors on the pipe ends</p>	<p>Protectors on the pipe ends</p>
